The Cornelius Point Eelgrass Restoration Project Shelter Island, NY

A Summary Report to:
The Peconic Estuary Program
Agreement # 525-8235-1120-00-00001

By:
Chris Pickerell
Stephen Schott and Kimberly Petersen
Cornell Cooperative Extension, Marine Program

January 2007

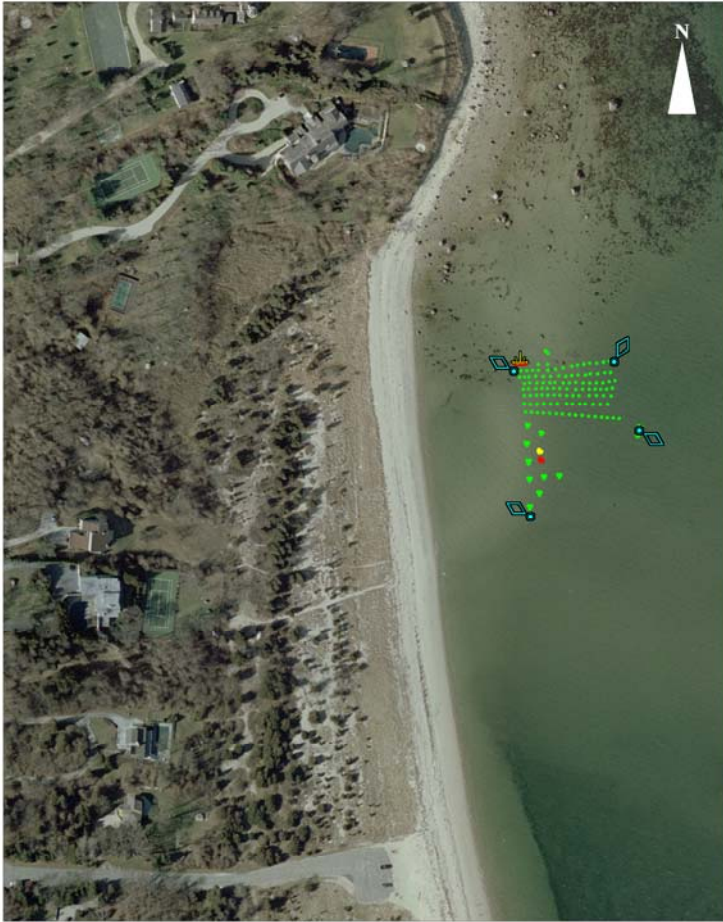
Figure 3. Plot map of the Cornelius Point, Shelter Island, NY eelgrass restoration project. Individual plot locations were generated using a Garmin GPSmap 76S handheld GPS overlaid on a 2004 aerial photograph. Corrections were made based on the known distance between plots.

In order to minimize the impact from crabs and currents to the planting plots, a circular plot layout was chosen over a typical square design. Individual 1m² circular plots were planted at approximately 2m intervals spread throughout the restoration site (Figure 3 & 4). Each plot was individually marked using a numbered rock (Figure 5) set on the sediment surface at the center of the plot. Although sand accretion at the center of the plots, caused by wave damping of the plant canopy, often caused burial of the rock, it was generally easy to relocate the rocks for subsequent plot identification and photographs.

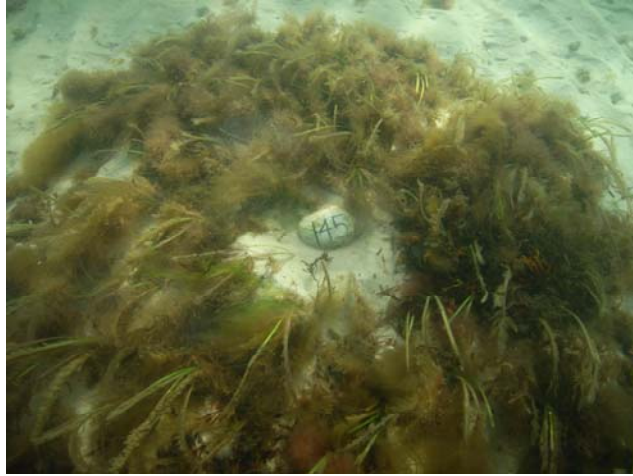
Figure 5. Typical 1m² circular planting plot showing numbered rock used to facilitate subsequent monitoring. Note the heavy algae growth attached to the grass typical of winter.

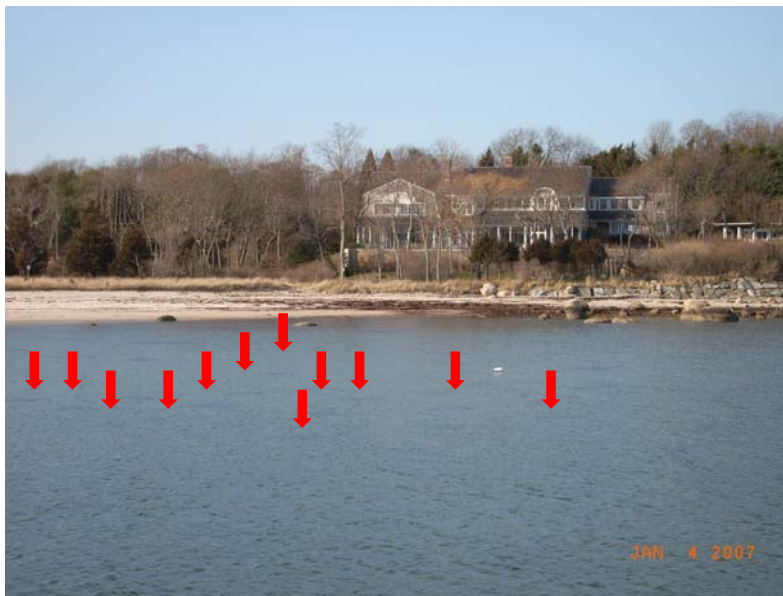
Figure 6. Oblique surface photo showing several of the 138 1m² planting plots at the Cornelius Point eelgrass restoration site. Photograph was taken on January 4, 2007.

The results for this project have been very successful to date. Nearly 30,000 adult shoots were transplanted to the site during the 2006 field season. Early test plantings (see Table 1) followed by the survival of the most recent plots indicate that this site is an ideal candidate for restoration. In fact, this is the first eelgrass restoration site in the Peconic Estuary where transplants have survived for more than one growing season. Plants from the original fall 2004 planting (more than 2 years old) still persist at the site today and show no signs of loss. It is expected that the majority of the plots planted during fall 2006 will persist through the winter and into the following spring when they will put on additional growth and expand. Figure 6 shows that the individual plots are visible from above the surface of the water. Over the next several years we expect the individual plots to coalesce into a continuous meadow.
